# City of Melbourne

## Council House 1

**WORKS: Main Switchboard Service,  
Repair & Upgrade Works**

**Date: Mar – Nov 2014**

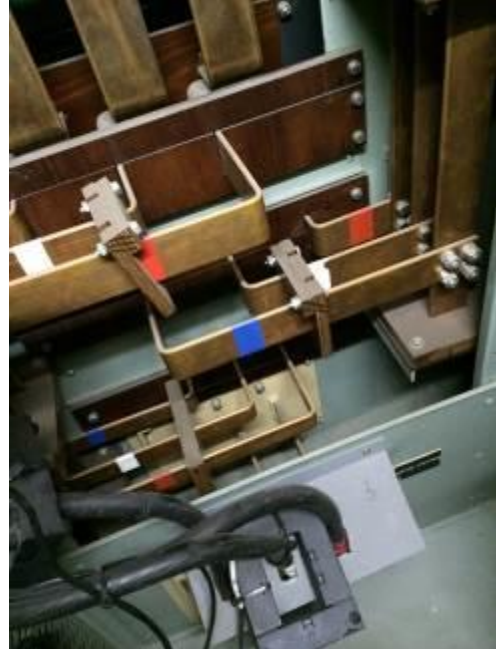
- Unmetered Tenant Chassis feeding 5 shops in Little Collins St required replacement due to obsolete & non-compliant equipment.
  - All Cables into MSB1 had previously been incorrectly installed into the switchboard, creating numerous potential hazards and allowing dust to enter the switchboard components

- Incorrect connections and switching arrangements shown on existing Single Line Diagrams and various labelling & demarcation on both MSB's obsolete or incorrect.

- To shut down power supplies to MSB1 & MSB2 over 2 nights, carry out all repair, servicing & upgrade works and return supplies to a fully functioning and tenanted multilevel city building (8 stories) + 5 tenanted shops.

- To remove & re-install up to 30 supply & circuit feeds into MSB through new gland plates, ranging from parallel 400mm Substation Feeds down to 25mm Fire Pump Supplies

- To provide temporary supply services to various building functions during power outage
- To Perform Maintenance on all Fuse Switches (CFS) & all internal connections

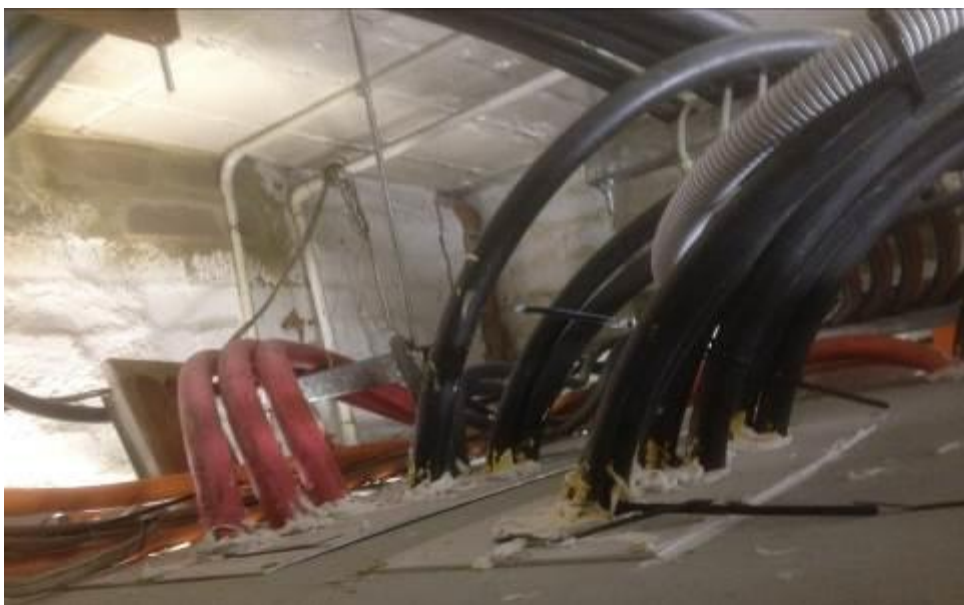
**Before: Main supply cables run directly into switchboard without correct cable restraint, mechanical protection or sealing of Switchboard against dust ingress**

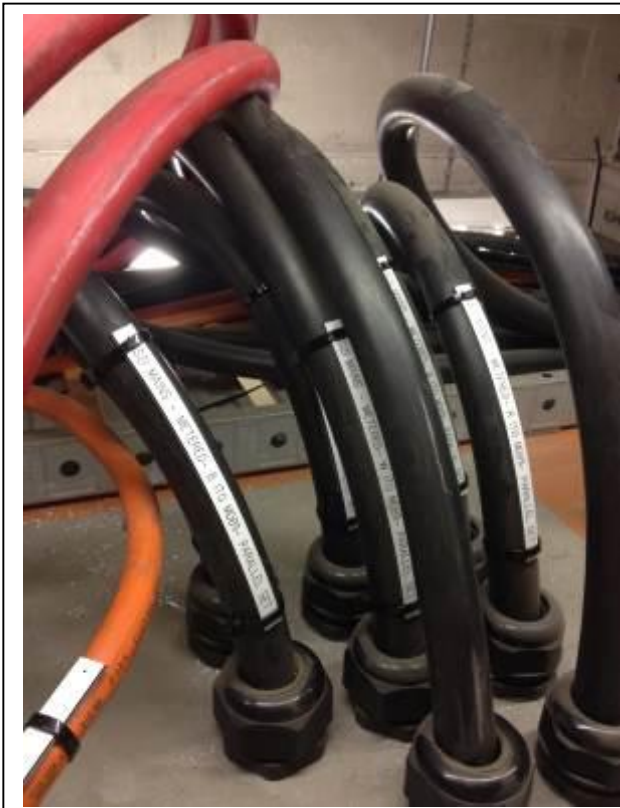
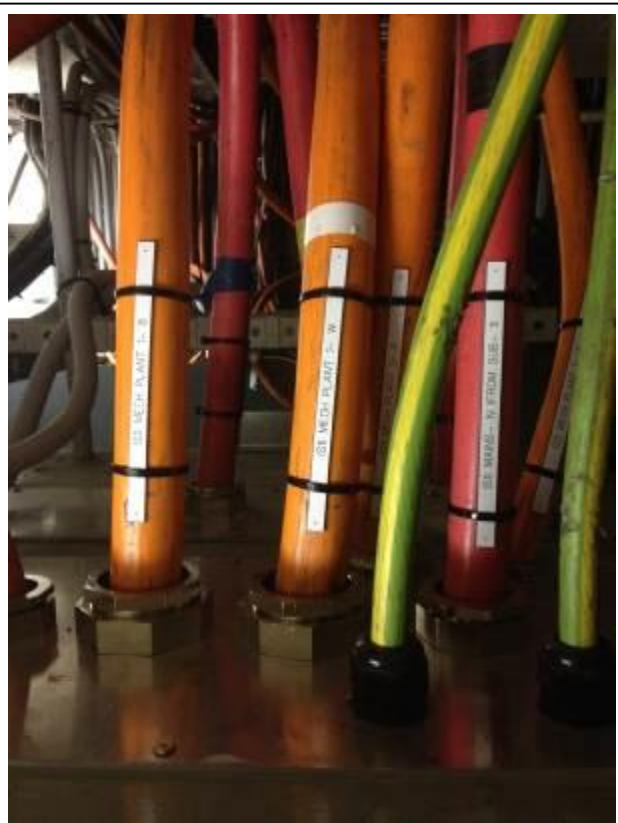
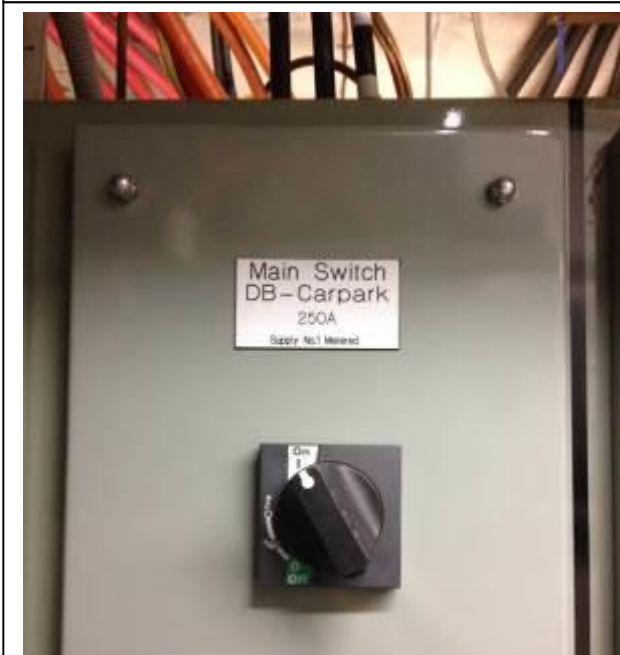
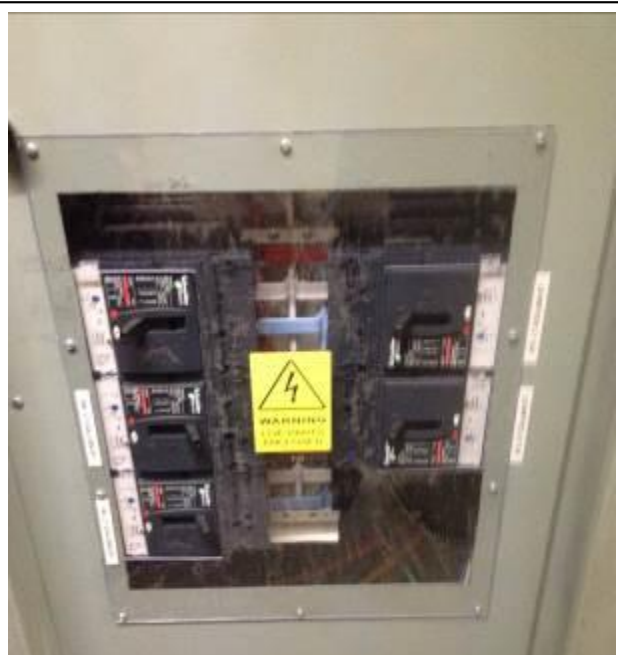
**After: Cables now installed through cable glands (Brass for FR Cables) with new gland plates and all cables labelled.**

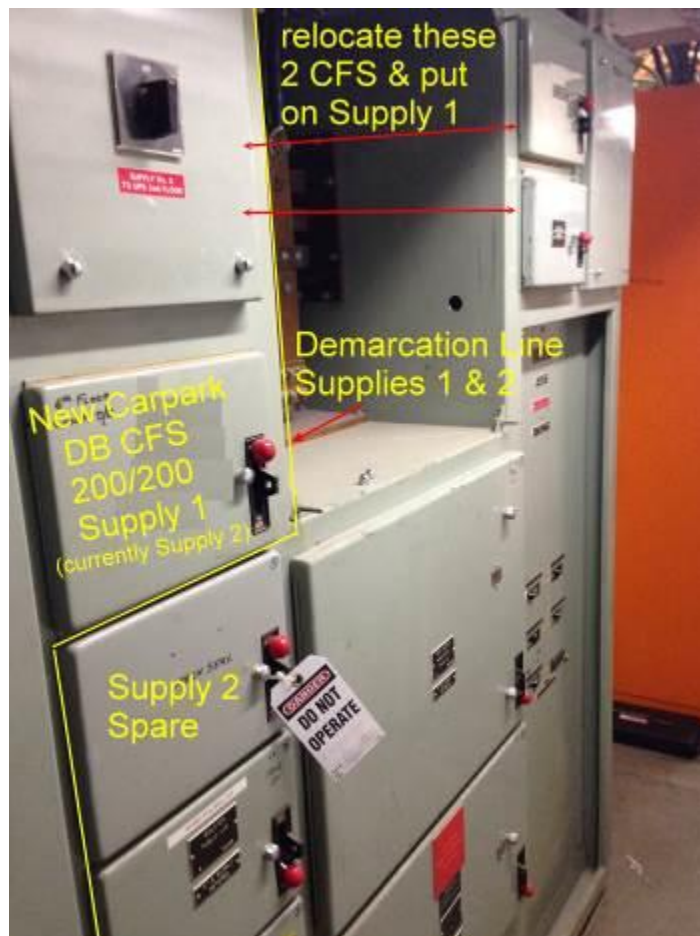
### Proposed solution

- A new 250 Amp 3 Phase MCCB integrated into MSB1 and feeding a remote dedicated car-charging distribution board would provide an effective & expandable platform for connecting the car-charging services

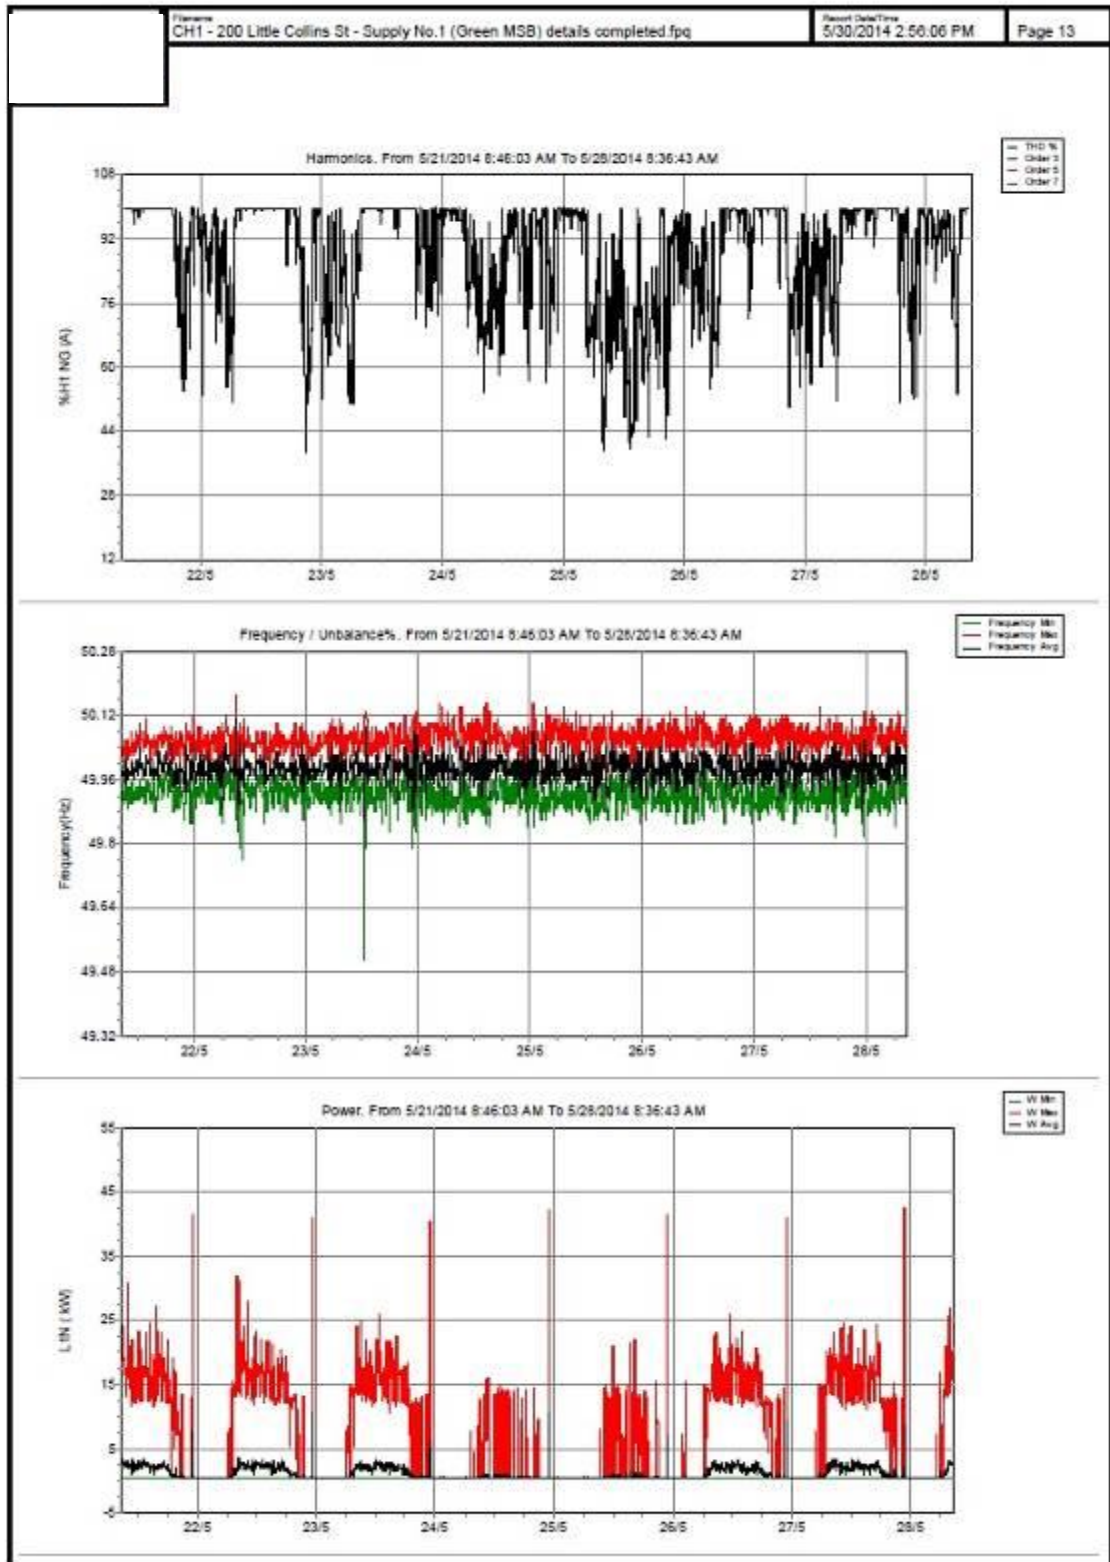
## Power, Harmonic and frequency analysis prior to works

- Items identified included:
  - Supply 1 had sufficient spare capacity for the prospective charge points however Supply 2 (feeding the Data Centre) was verging on being fully committed

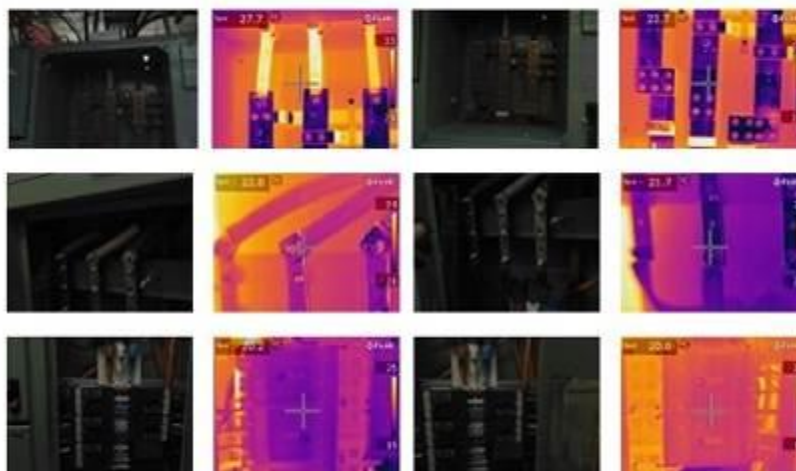
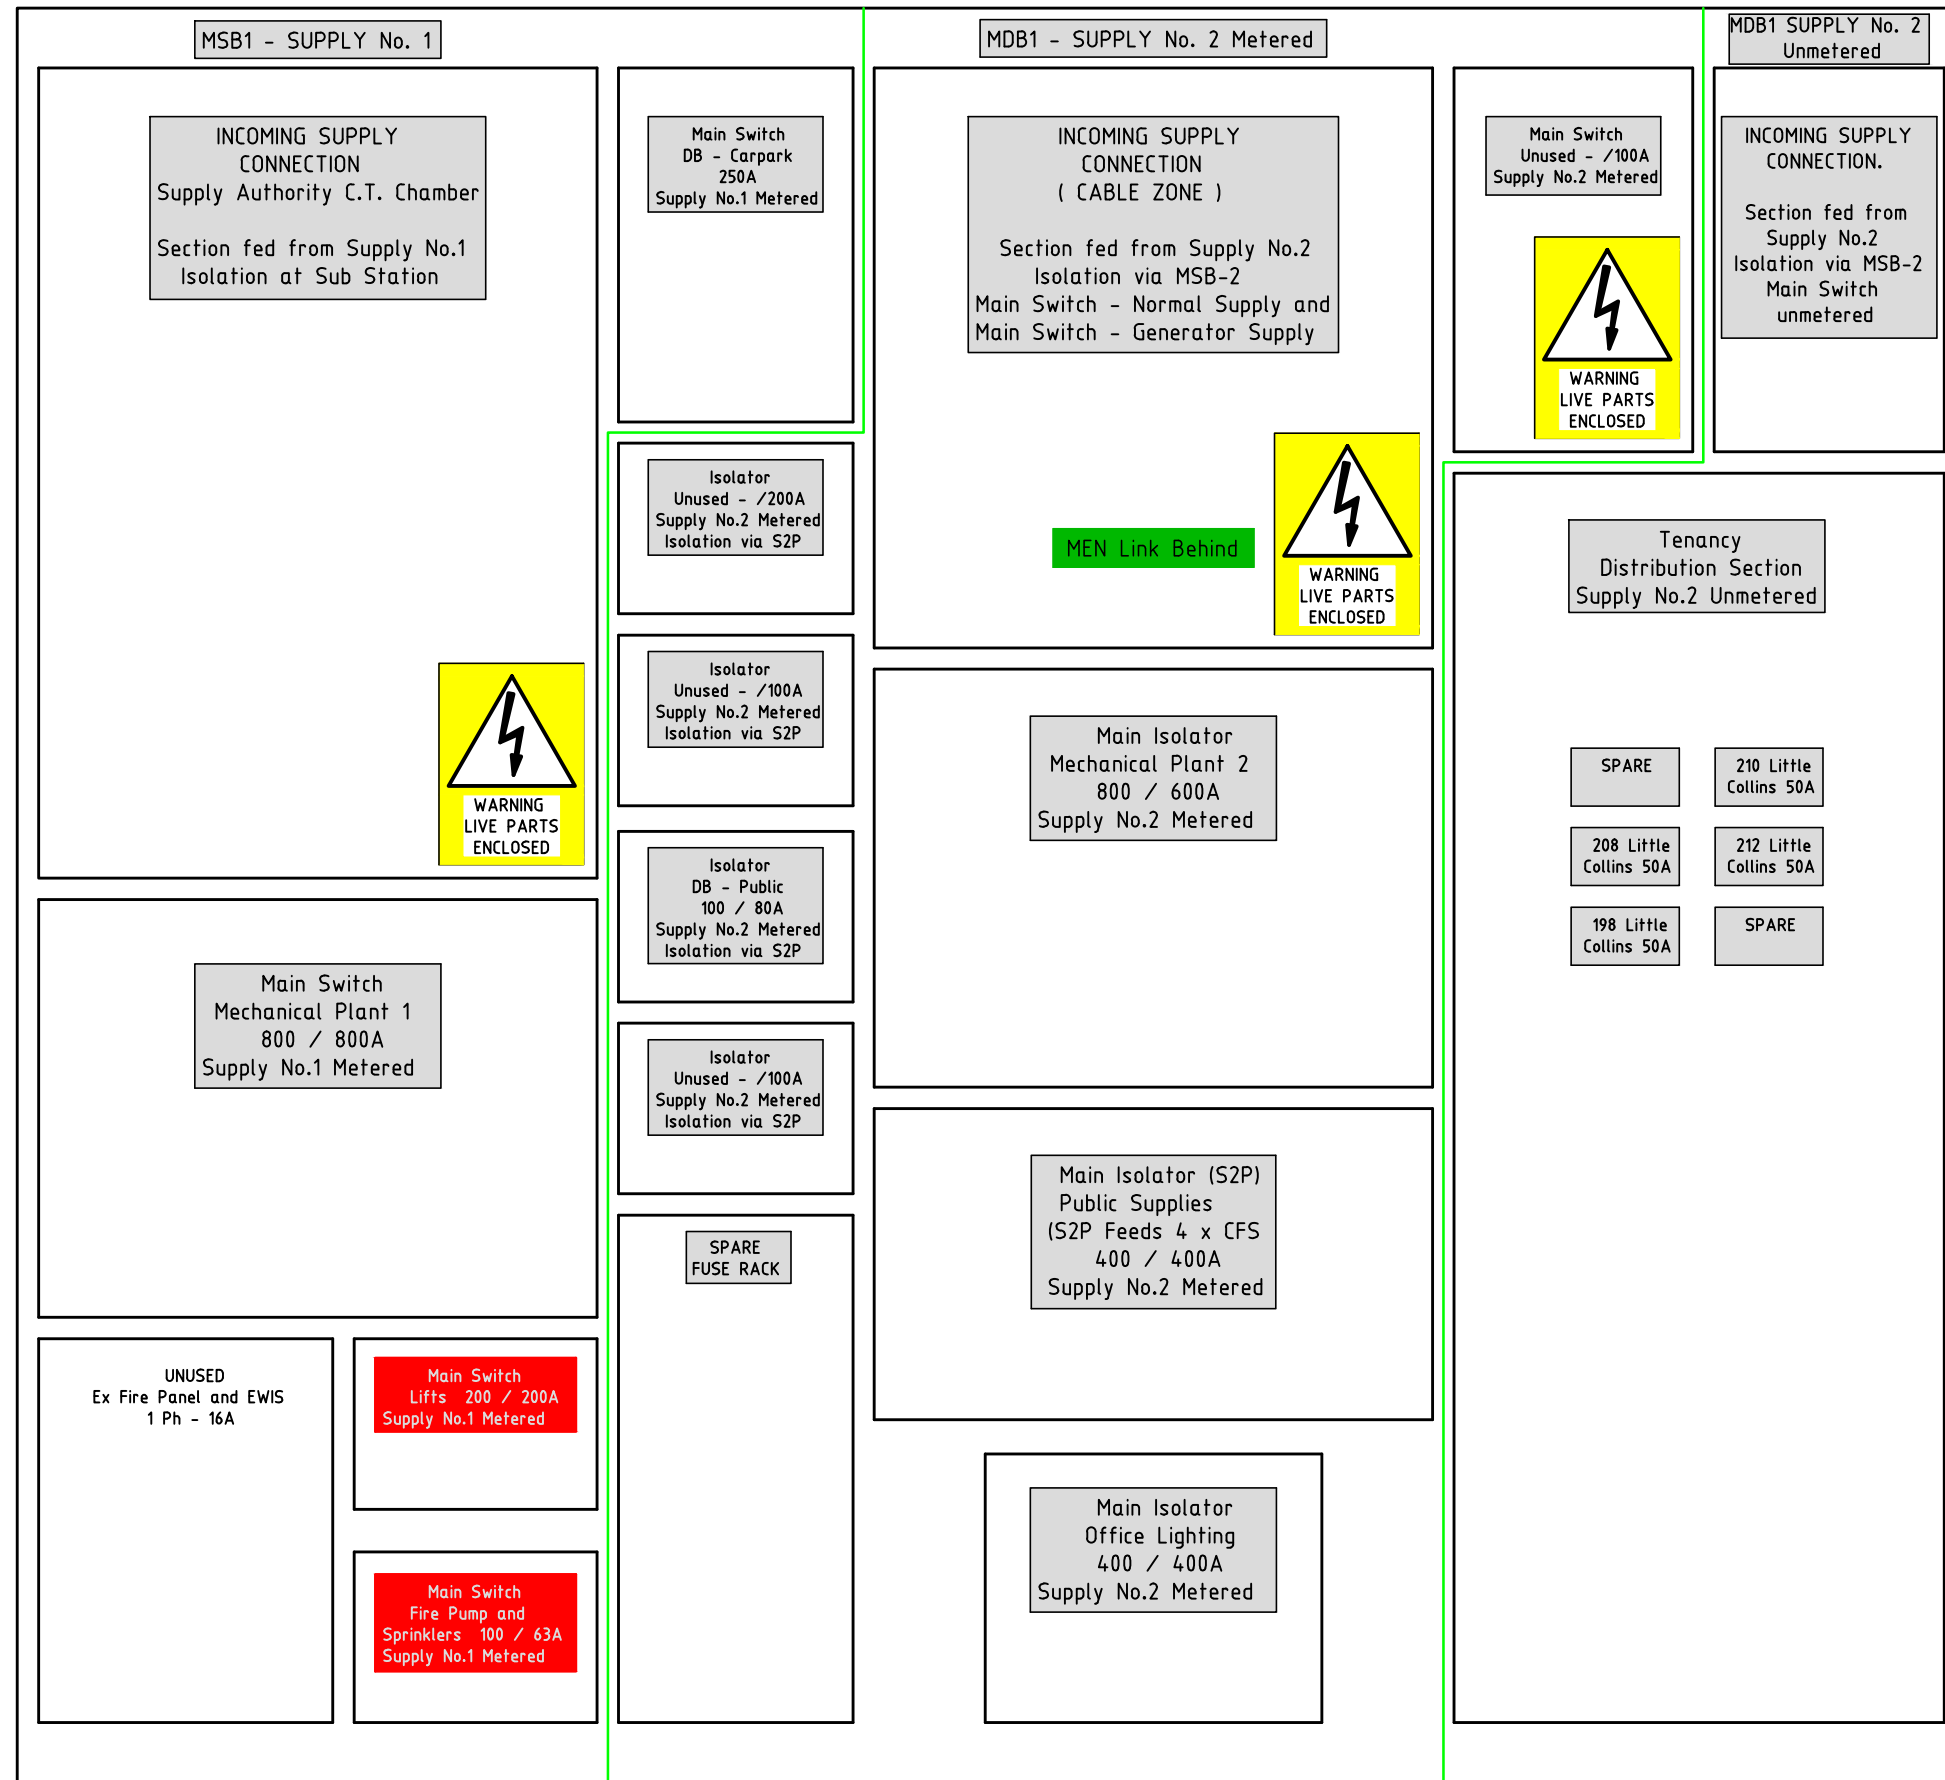
### Panel Photos and Images

For the equipment inspected we have recorded a total of 0 thermographic images documenting exceptions detected during our inspection.

In this instance however, we have included thermal and visual images for all the areas concerned, showing the normal thermal activity present. These images were taken on the follow up survey in the 24<sup>th</sup> July

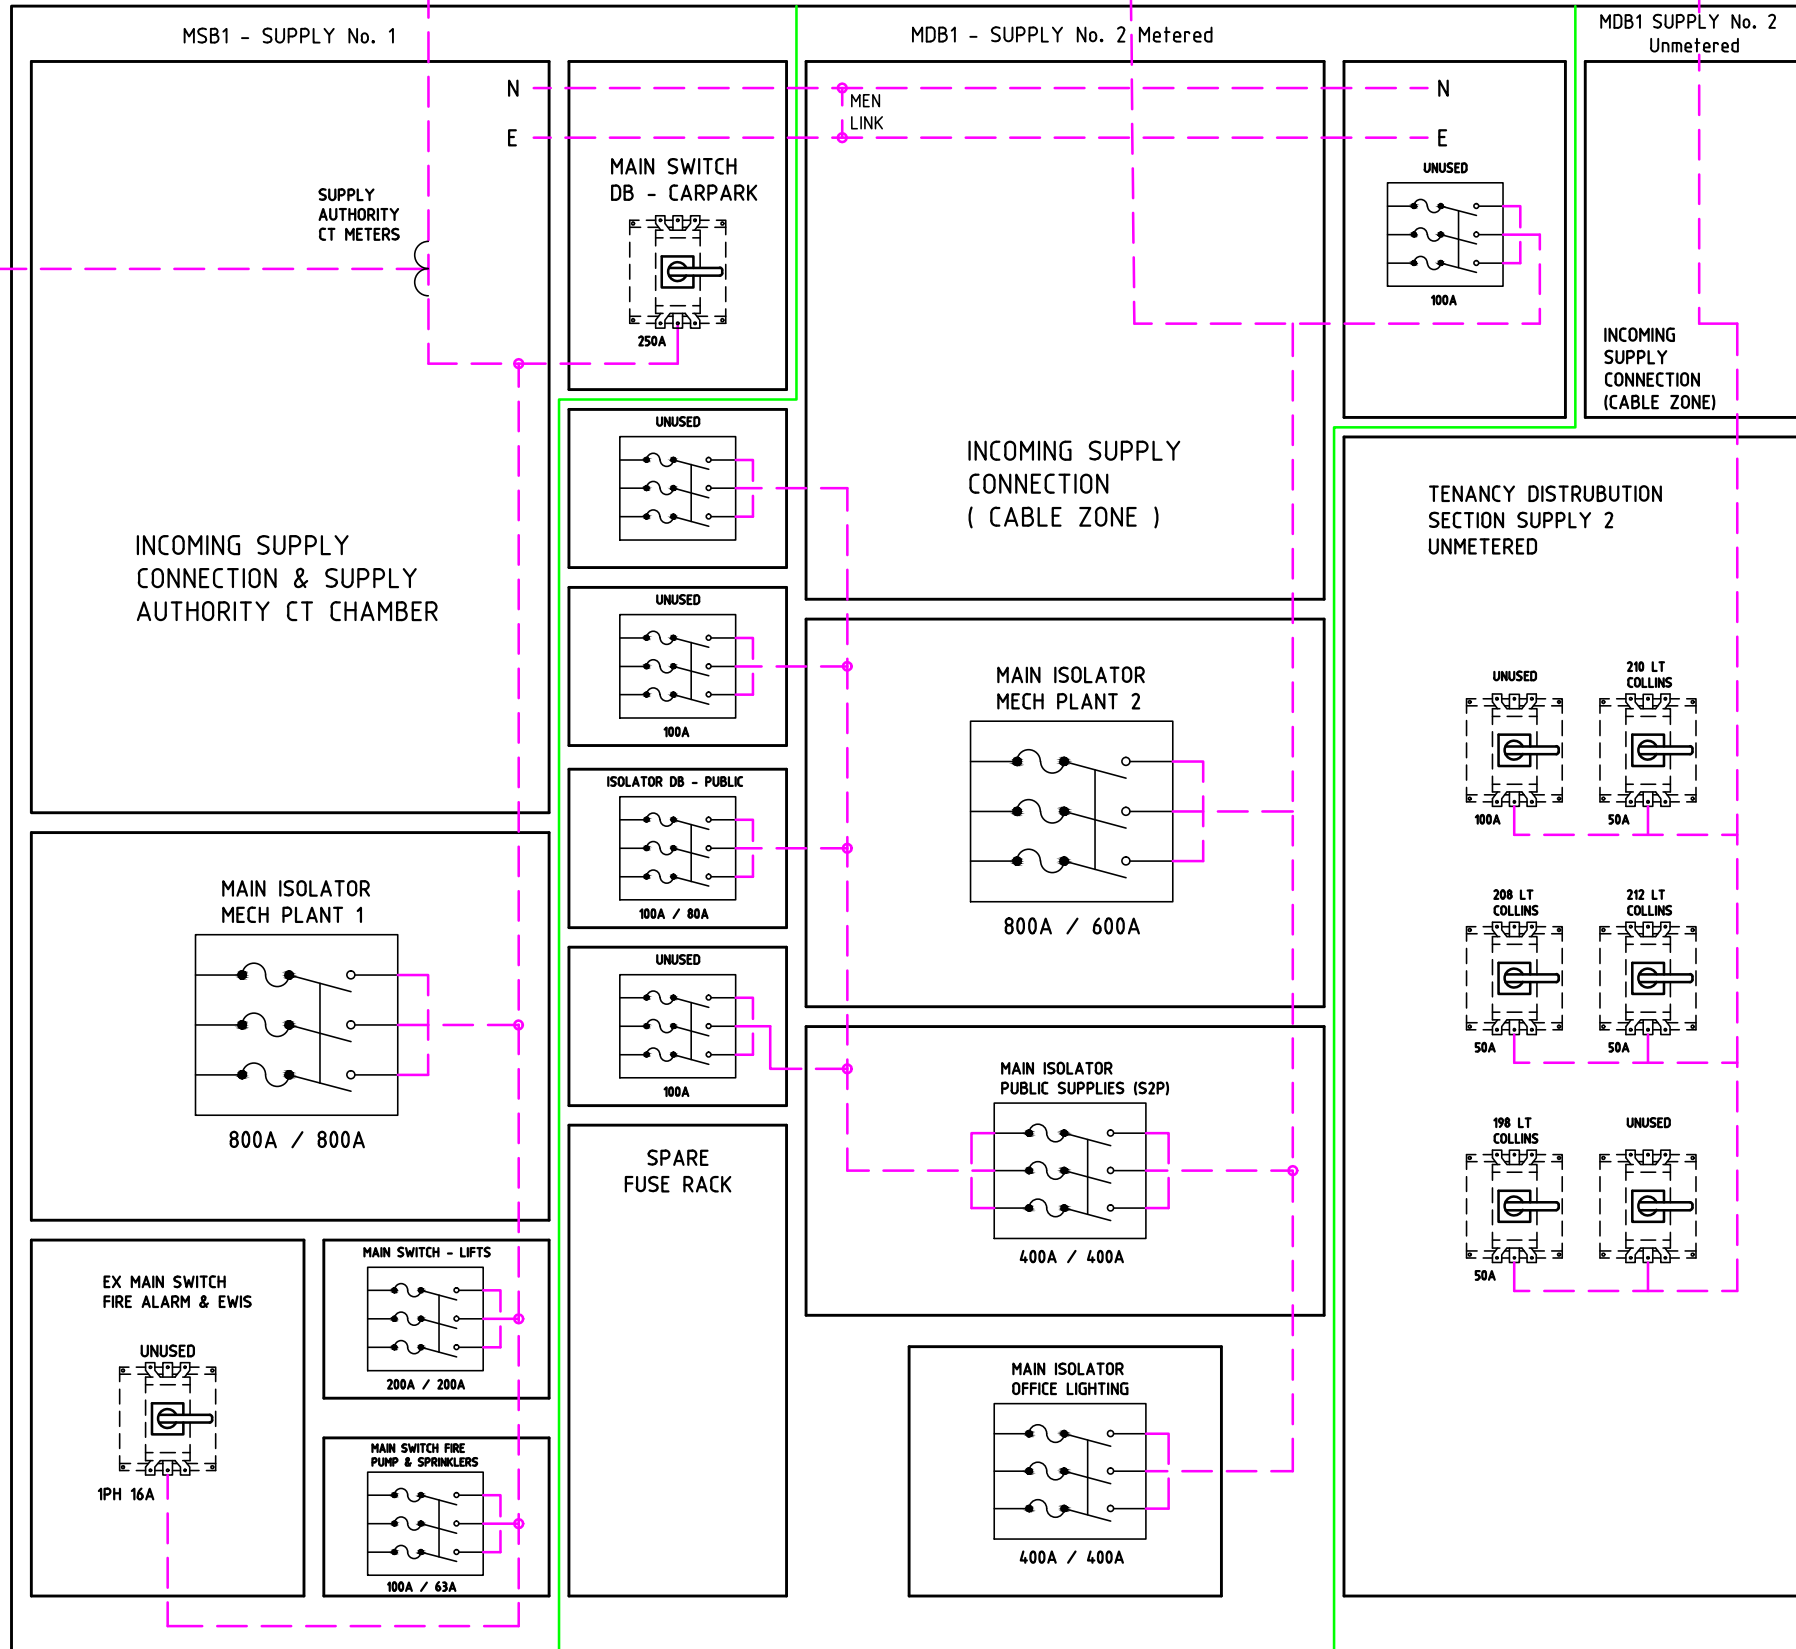
City of Melbourne  
COUNCIL HOUSE 1 - MSB-1  
FUNCTIONAL DRAWING

SUB STATION  
SUPPLY No.1

FROM MSB2 MAIN SWITCH  
- METERED

FROM MSB2 MAIN SWITCH  
- UNMETERED

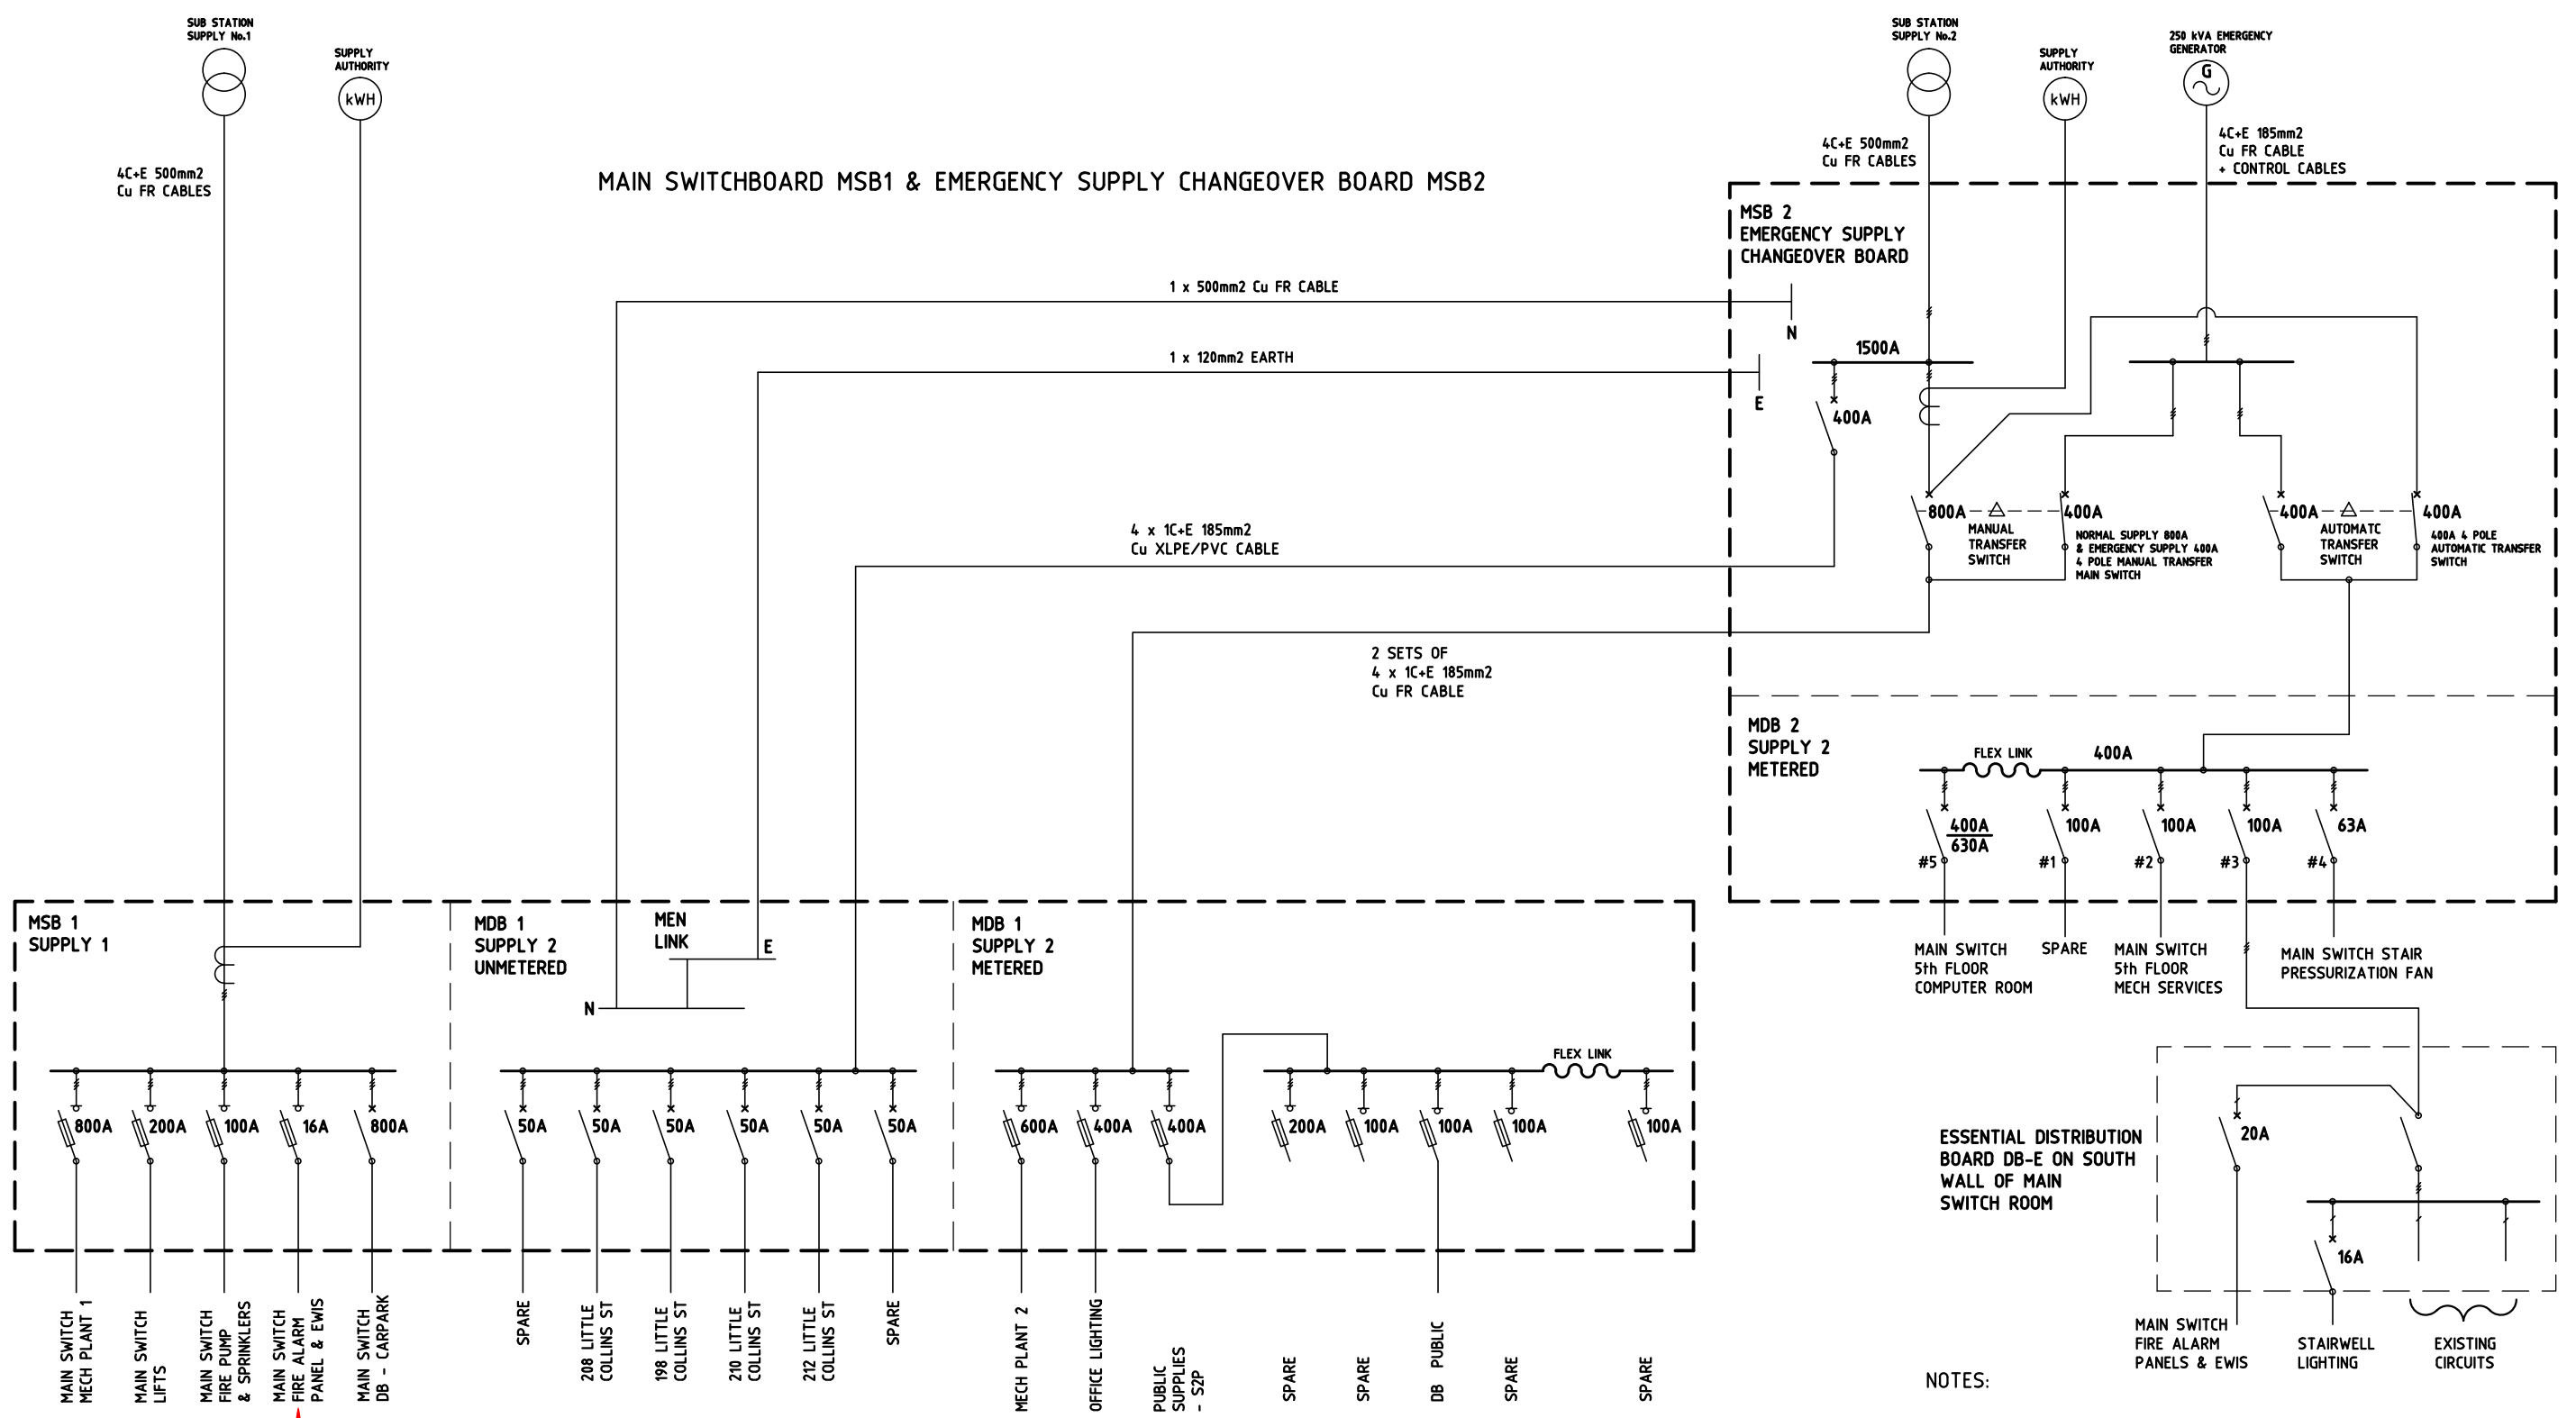
Title : **City of Melbourne COUNCIL HOUSE 1 - MSB-1 SINGLE LINE DIAGRAM**

Currently fed from DB-E.  
May be Recommissioned in  
Future Power Revision
